Board of Directors Regular Meeting

**Barn 8 Dance Hall
Structural Evaluation Report**

Sudden Valley Community Association (SVCA)
8 Barn View Drive
Sudden Valley, WA 98229

11/15/24

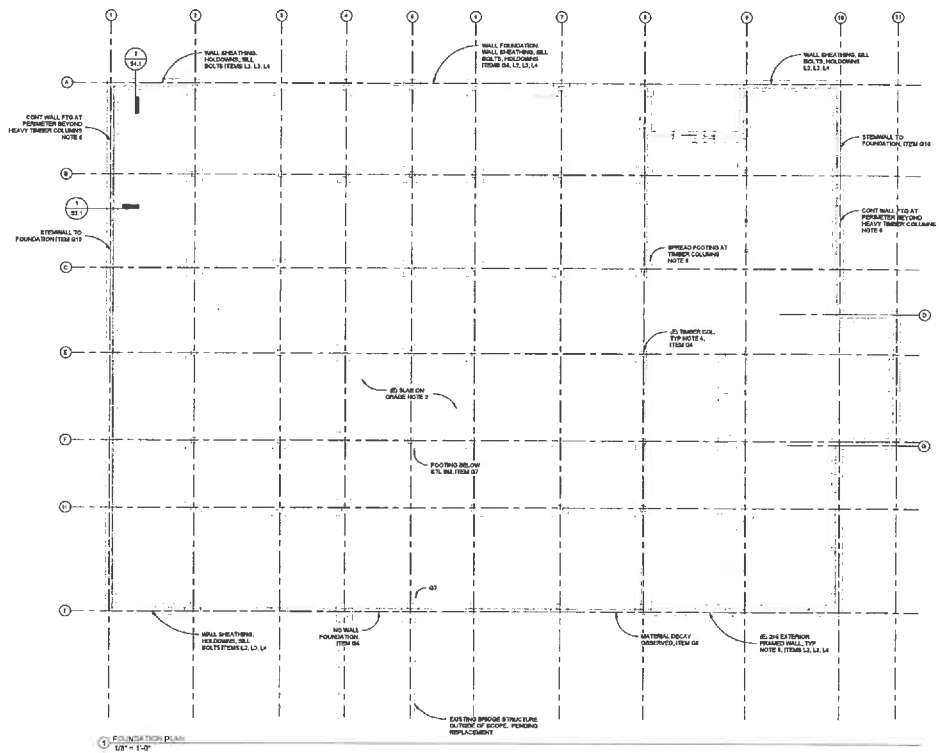
FOUNDATION PLAN
1/8" = 1'-0"

The exterior wall foundations were exposed at two locations for Kingworks review while on site. The exterior walls that are on the North and South ends of the building are supported on continuous wall footings with a concrete stem wall. The footing appeared to be 2-ft wide with an 8-in thick concrete stemwall. The footing size observed at these locations appeared adequate for the loads they were supporting. Horizontal reinforcement appeared to be present in the stemwall and foundation based on the scanning results. No vertical bars connecting the stemwall to the foundation were found by the reinforcement scanner. Connection between the stemwall and foundation is needed to prevent separation or detachment between the two during a wind or seismic event. It is possible that vertical reinforcement is present at a large spacing and the area scanned was within that spacing. A positive connection between the stemwall and foundation could be made by adding structural steel angles that are anchored to both the concrete foundation and concrete stemwall, or core drilled rebar epoxy dowels through the stemwall to the foundation could be added.

The east and west exterior walls rest on the slab on grade without thickened edges or additional foundations. Although these walls do not carry significant gravity loads, they function as shear walls to resist lateral forces. Typically, a continuous wall foundation or thickened slab edge is used to support vertical wall loads and provide frost protection. Saturated soil beneath the slab edge may freeze and expand in cold conditions, leading to frost heave and potential lifting of the slab and exterior wall. The City of Bellingham recommends a minimum depth of 12 inches for exterior footings to ensure frost protection. This issue could be mitigated by underpinning the slab with reinforced concrete grade beams on these sides of the building.

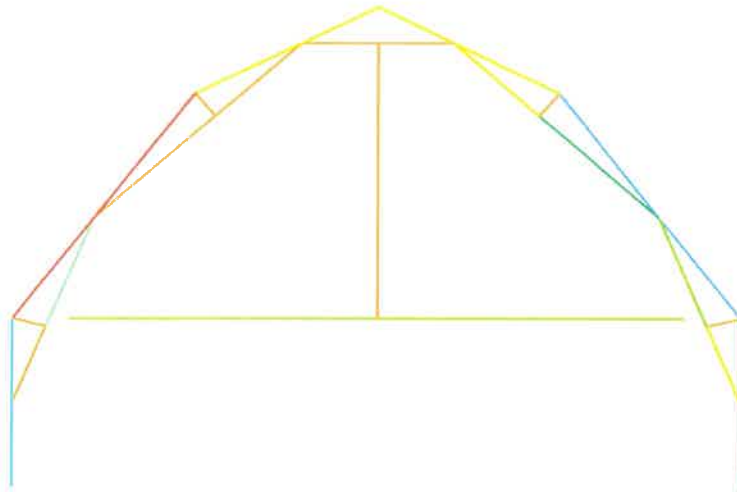
TRUSS AT TIE RODS - EXISTING CONDITION (NOT BRACED BY ADJACENT DIAPHRAGMS)
UNBALANCED WINDLOAD APPLIED (WINDWARD POSITIVE, LEEWARD NEGATIVE)

AXIAL LOADS EXCEED NAILED CONNECTIONS CALCULATED ON PREV PAGES

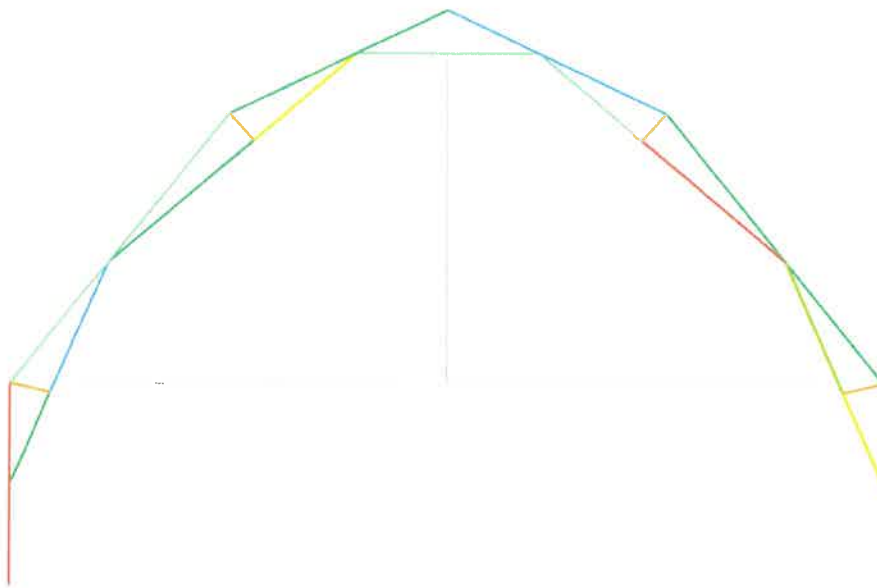
TRUSS AT TIE RODS - ASSUMING BRACED BY ADJACENT DIAPHRAGMS VIA NEW CONNECTIONS

NAILED CONNECTIONS WITHIN CAPACITIES CALCULATED EARLIER IN PDF

Kingworks found if the trusses are tied into the adjacent roof diaphragms it reduces the demand on these knee brace conditions to be within allowable limits. This attachment could be achieved with supplemental structure such as steel plates and straps from the truss chords to the adjacent roof rafters. This approach would require the diaphragm has adequate capacity and a load path the resist the force at the base of the trusses. Adding additional interior shear walls and installing plywood sheathing to the top or bottom of the roof rafters would likely be required.
