Board of Directors Regular Meeting

**Barn 8 Dance Hall
Structural Evaluation Report**

Sudden Valley Community Association (SVCA)
8 Barn View Drive
Sudden Valley, WA 98229

11/15/24

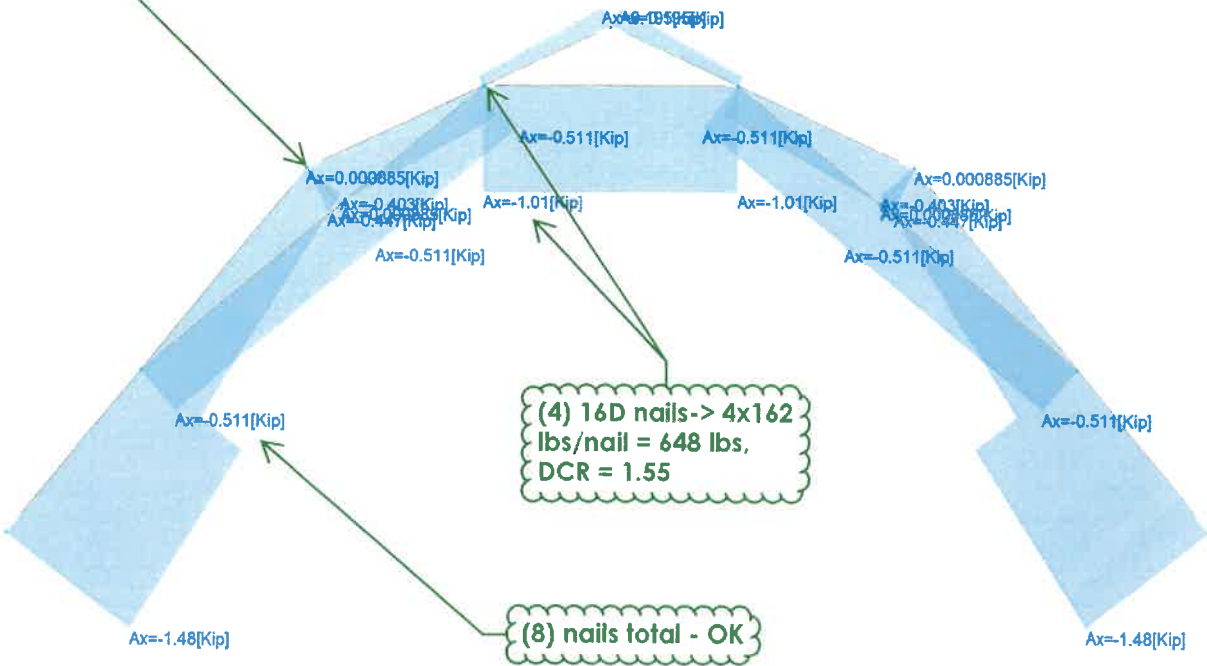
(5) 16D nails -> 5x162
lbs/nail = 810 lbs,
DCR = .55, ~ok

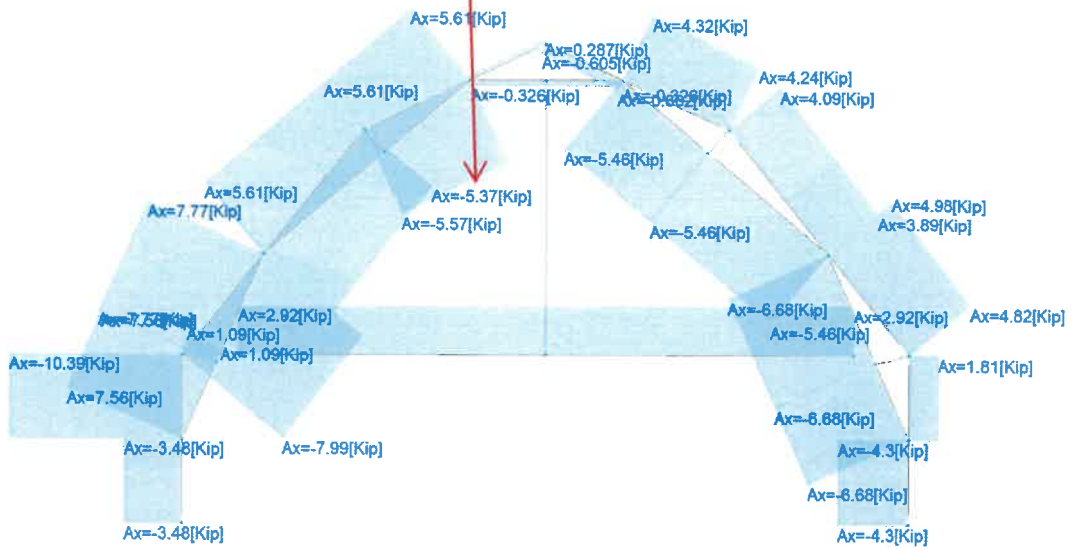
TRUSS AT TIE RODS - EXISTING CONDITION (NOT BRACED BY ADJACENT DIAPHRAGMS)
UNBALANCED WINDLOAD APPLIED (WINDWARD POSITIVE, LEEWARD NEGATIVE)

The Gambrel trusses have a steep pitch with a prominent projection above the main roof. Wind pressures act perpendicular to the roof plane of a building and wind pressure during a code level event on this type of roof creates a larger horizontal force than a typical roof. The trusses appear to resist this loading condition with additional wood diagonals from the columns, creating a knee brace type of configuration. The gambrel trusses were analyzed for this lateral loading condition and the truss members and their connections were found to be inadequate.

AXIAL LOADS EXCEED NAILED CONNECTIONS CALCULATED ON PREV PAGES

Kingworks found if the trusses are tied into the adjacent roof diaphragms it reduces the demand on these knee brace conditions to be within allowable limits. This attachment could be achieved with supplemental structure such as steel plates and straps from the truss chords to the adjacent roof rafters. This approach would require the diaphragm has adequate capacity and a load path the resist the force at the base of the trusses. Adding additional interior shear walls and installing plywood sheathing to the top or bottom of the roof rafters would likely be required.

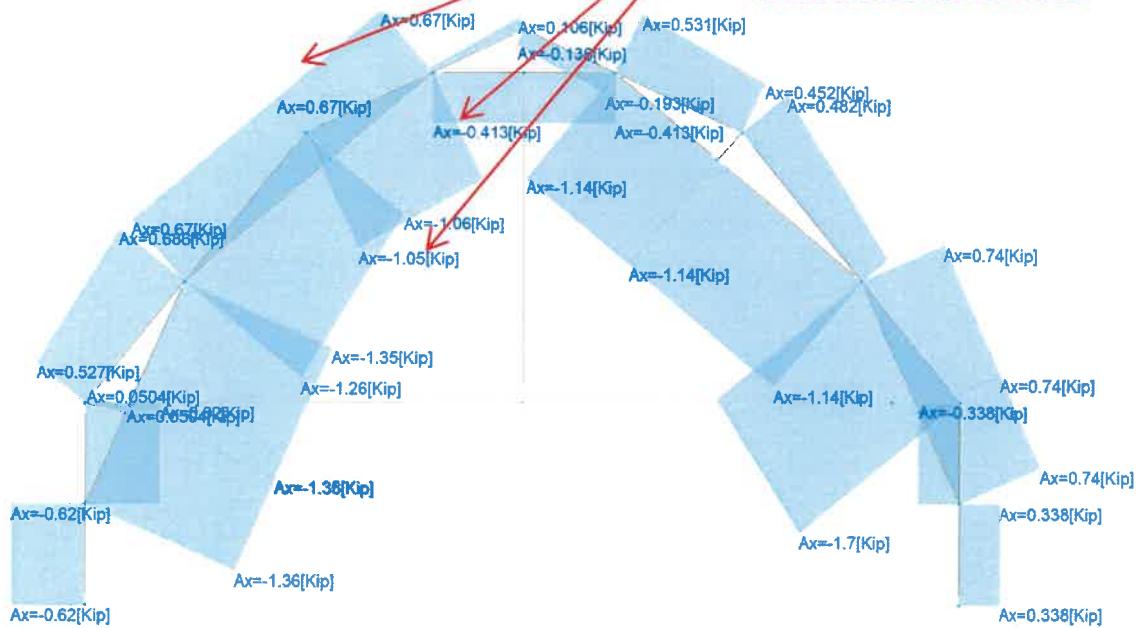
UNBALANCED WINDLOAD APPLIED (WINDWARD POSITIVE, LEeward NEGATIVE)

NAILED CONNECTIONS WITHIN CAPACITIES CALCULATED EARLIER IN PDF
